2012 Watershed Tour

Summary

Members of the Lakes & Waterways commission and invited guests were given a tour of the many important water control structures that make up the Powow River watershed. The tour was led by DPW Director Rob Desmarais and Town Engineer Pete Manor.

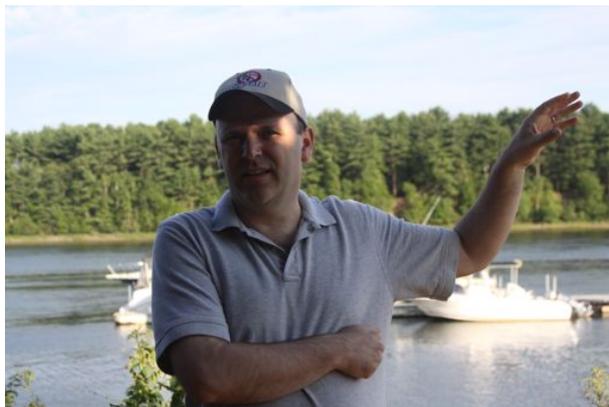
Merrimack River presents erosion problems during floods. Pleasant Valley Rd. land being private makes it hard to repair erosion on the shoreline.

Each storm brings back the shoreline a little bit more.

The Army Core of Engineers added the existing gabions along the eastern side of the mouth of the Powow in the late 1970's or early 1980's as a solution to erosion problems.

The town is pursuing a grant with federal highway to try to protect it. A similar problem on River Rd. in Merrimac, MA resulted in the road being abandoned. Amesbury would like to get the money they abandoned.

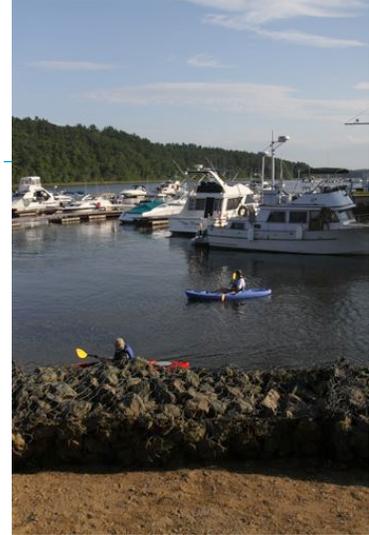
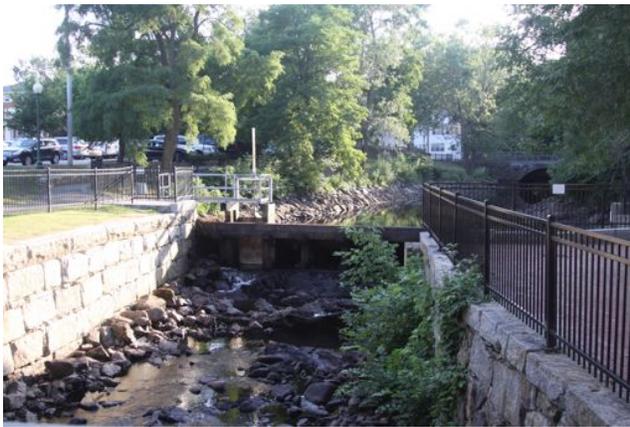
Crib Dam in Millyard

The Upper Millyard is the site of many former penstocks. A large pipe went under Amesbury Industrial and another penstock ran under mill where Ovedia is. The tunnels left voids under the road. In the past, a sink hole formed in the Amesbury Industrial parking lot because of caverns where penstock used to come into the mill.

The wall near the upper bridge and near the amphitheater both failed in 2006 and were replaced in 2011 with funding by FEMA. Granite blocks were salvaged from Gloucester.

Other river walls are made of various materials but are at risk for failures due to trees and also high water.

If one of the buildings the river flows under were to collapse, it could block the river. Not much is holding up those buildings.

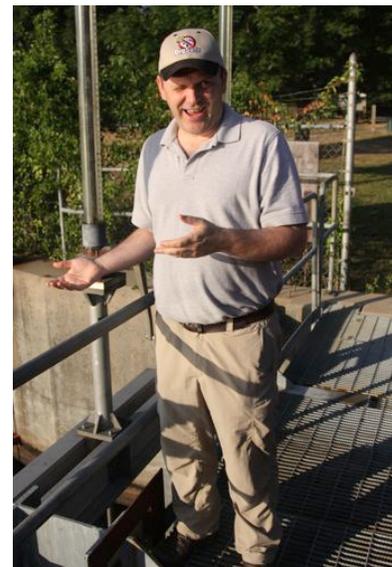
Lake Gardner Dam

In 1999 or 2000, the lake was drawn down for 4 years for the project to build the stability berm. The current dam is reinforced concrete. The granite blocks are a facade. A "skilling pool?" below the dam is 2 ft. deep and its purpose is to act like buffer, slowing the water to prevent scour on the concrete structure. The structure of the dam is built on 8 anchors that go 65 ft to bedrock.

could not be done in winter or once a flood starts. Stop-locks have been replaced with mechanical sluice gates.

The emergency spill-way had release bolts but have since been disabled.

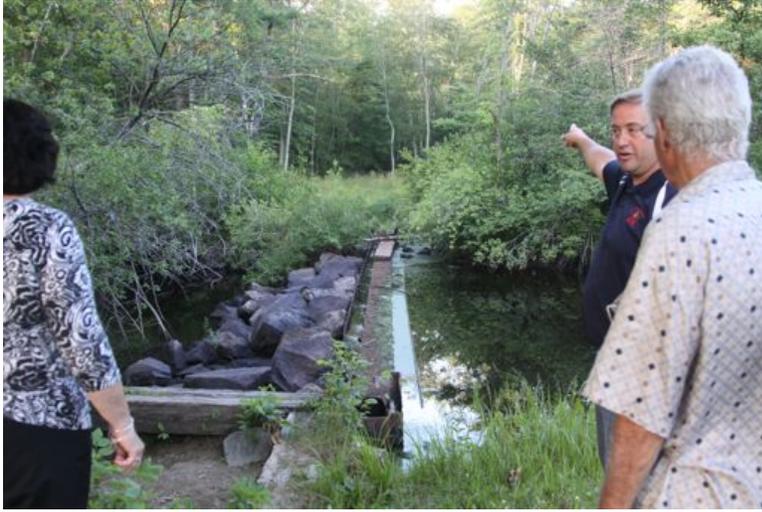
The Weir on the Powow

The weir is a 140 ft wall that keeps the river at the correct height for pumping. It is part metal and a timber section extends beyond the main part of the river.

The sheet metal on the dry side is starting to deteriorate. Timber also rots. In 2003, rocks were added downstream of the weir for stability; to keep it from falling over. The proposed plan is to build another weir in front of it and fill the void with concrete to

The weir is low risk, but critical for water supply. Sheet piling could be stockpiled and replaced in an emergency.

create a concrete structure.

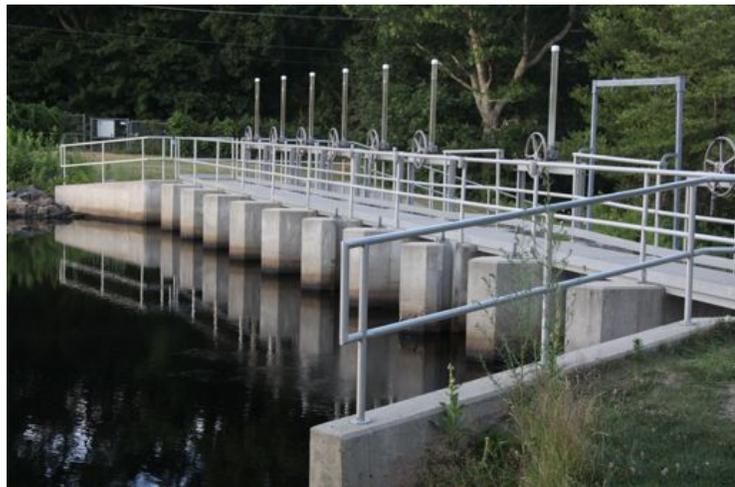
Tuxbury Pond Dam

The water below the dam is visibly heavy in iron and manganese. A visible sheen on the water is algae and often mistaken for an oil sheen.

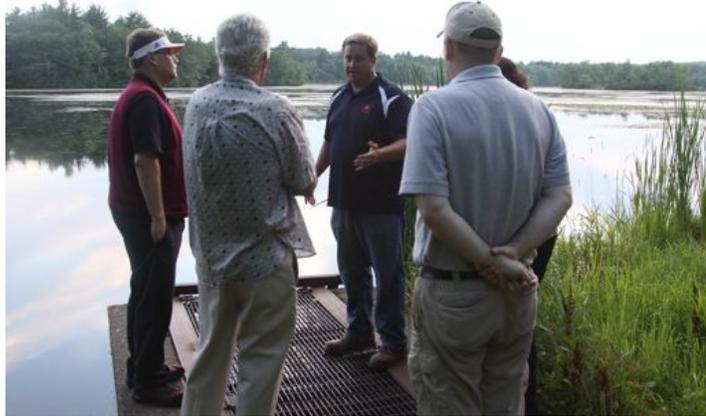
Archbrook Culvert

The 5' x 2' culvert is 120 ft in length and made of granite lintel beams on field stones.

The existing culvert looks like a metal grate over a hole in the ground with wooden stop-locks which can be adjusted to control the level of Meadowbrook Pond.

The capital plan has a cost for replacement.
