2012 Watershed Tour

Summary

Members of the Lakes & Waterways commission and invited guests were given a tour of the many important water control structures that make up the Powow River watershed. The tour was led by DPW Director Rob Desmarais and Town Engineer Pete Manor.

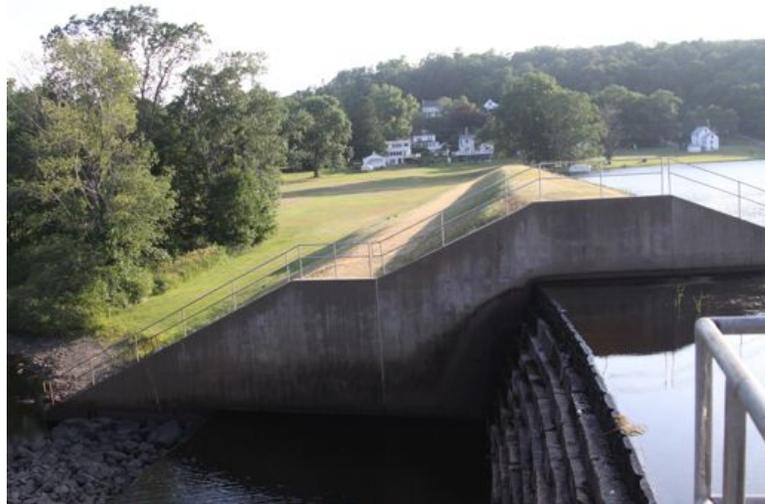
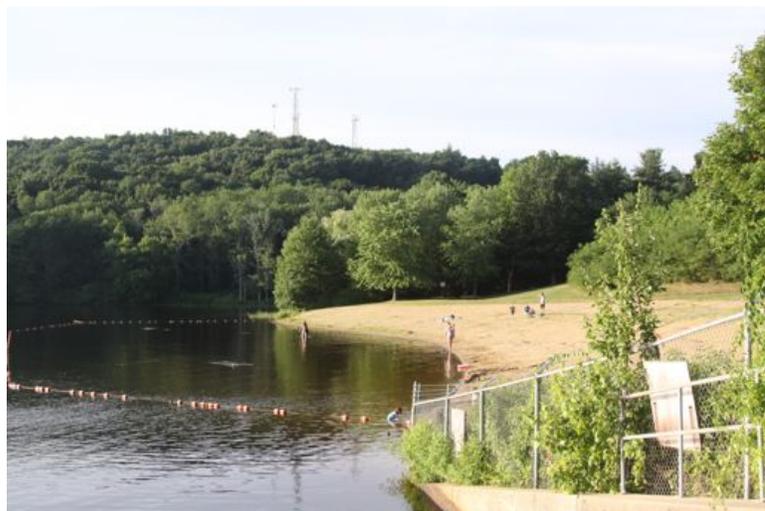
The dam is downstream of a 52-square-mile watershed.

The dam was constructed in 1860 and rebuilt in 1920's. It was rebuilt again in 1987 when two former powerhouse buildings were starting to coming down. In 1993, the powerhouse buildings were taken down and replaced with a retaining wall.

In 1999 or 2000, the lake was drawn down for 4 years for the project to build the stability berm. The current dam is reinforced concrete. The granite blocks are a facade. A "skilling pool?" below the dam is 2 ft. deep and its purpose is to act like buffer, slowing the water to prevent scour on the concrete structure. The structure of the dam is built on 8 anchors that go 65 ft to bedrock.

could not be done in winter or once a flood starts. Stop-locks have been replaced with mechanical sluice gates.

The emergency spill-way had release bolts but have since been disabled.

Even when opened a small amount, water shoots out very quickly and very powerfully from the gate.

Any sand that builds up on the dam is released when the gates open. (Channel is 16 ft deep and concrete is angled up.) Weeds in front of dam are not considered problem because a concrete apron tapers down.

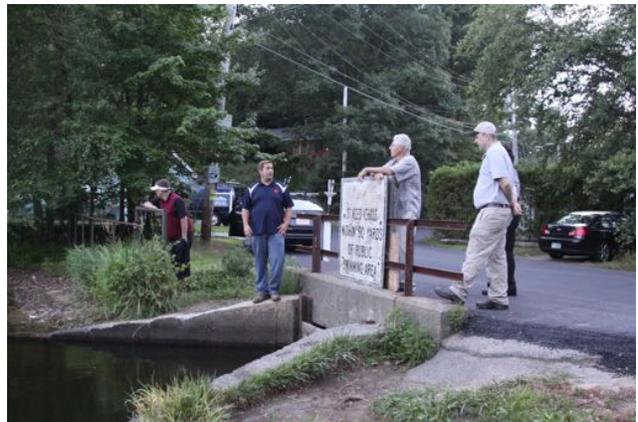
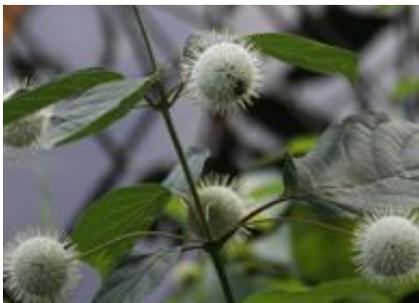
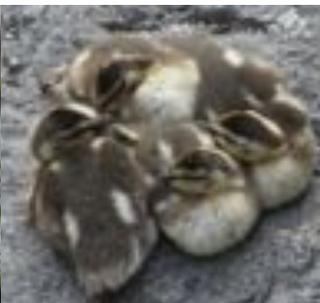
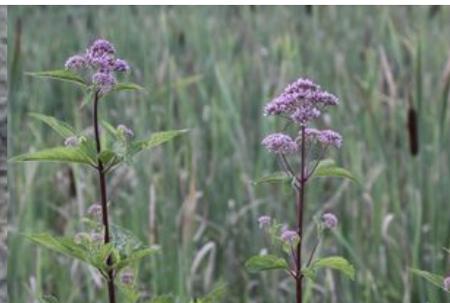
The structure was created in late 1970's and hasn't changed. The water line over the bridge was replaced in 1996.

This dam is also a bridge, so if the dam was to flood, there is no other way out for the Birchmeadow Rd. neighborhood.

To the right is a public boat launch. To the left is Amesbury's public access beach as required to qualify for grant money.
